Claim	: 10547 AAV
Aircraft	: Bell 206 L-3 helicopter
Location	: Toluca International Airport, State of Mexico
Being offered	: As is where is
Contact Information	: Pablo Bañuelos Marquez; pablobanuelos@ifasoc.com

Aircraft Details

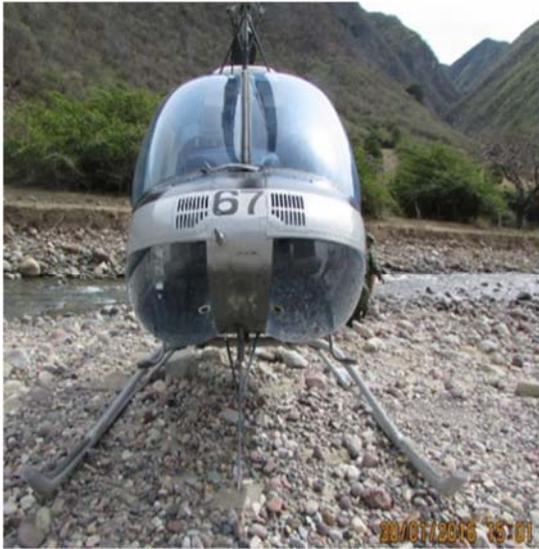
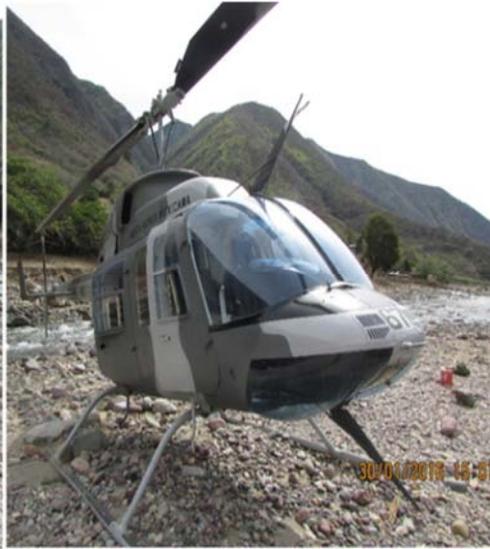
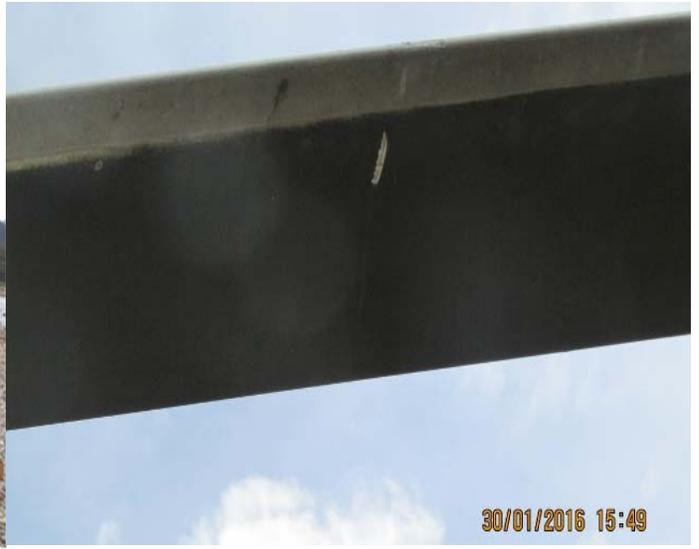
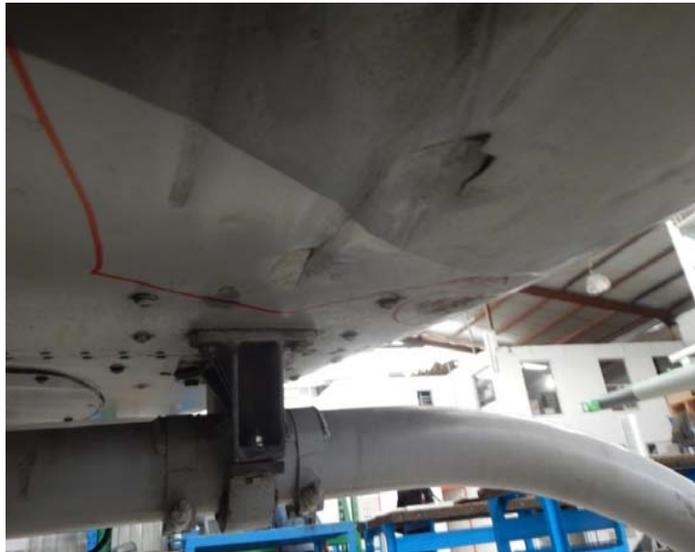
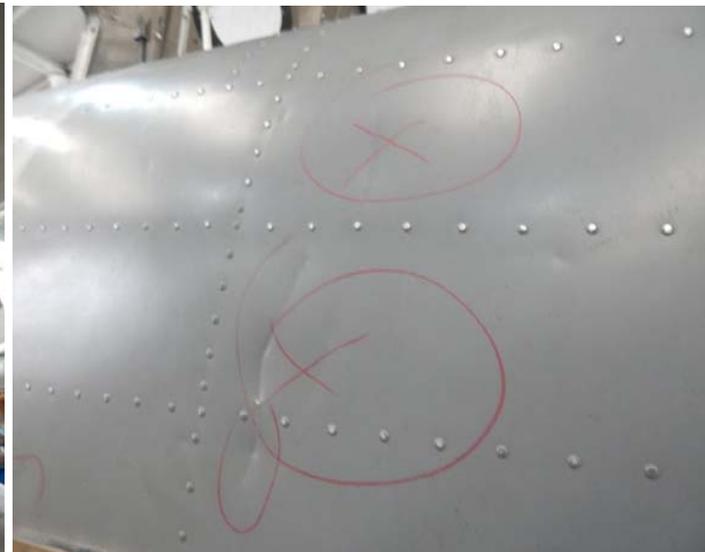
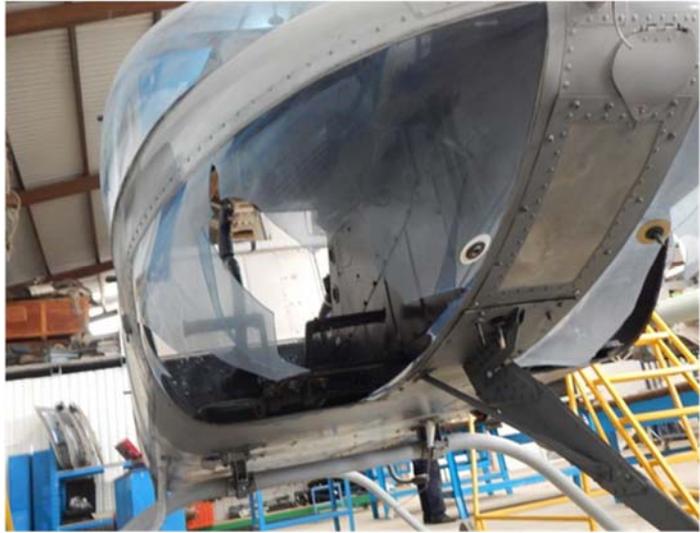
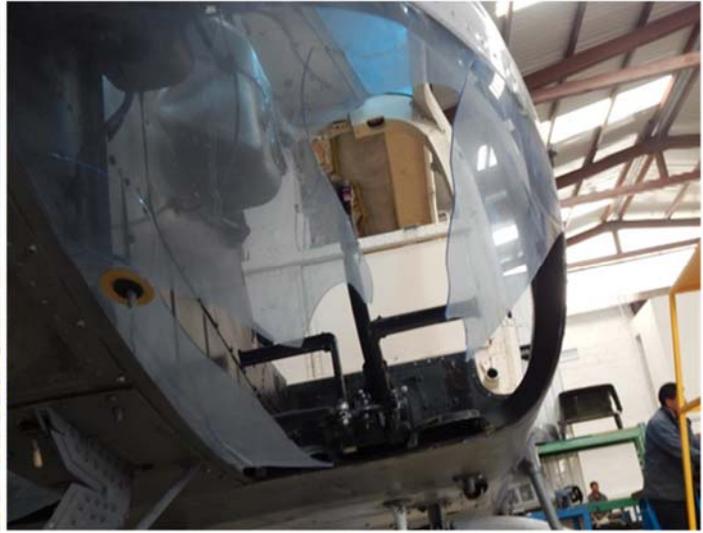
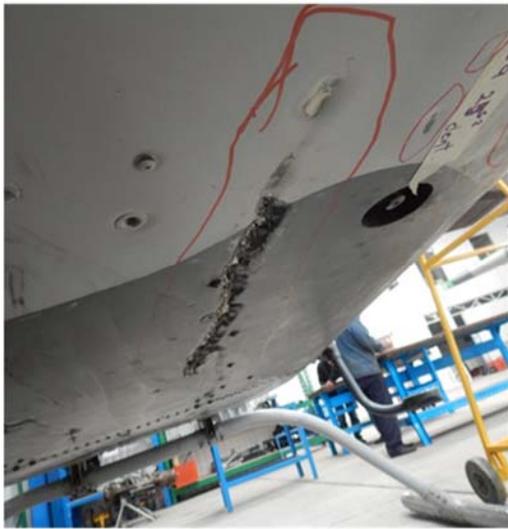
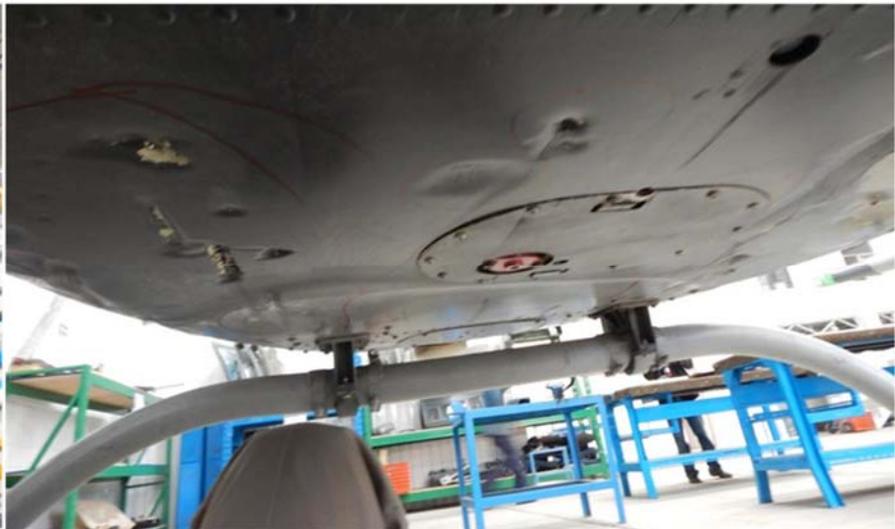
Due to the heavy landing, the helicopter sustained damage to: the main rotor hub assembly (including the pitch links); the swashplate assembly; one main rotor blade; the upper wire cutter. In addition, the engine and transmission require sudden stop inspections.

As a result of the rescue operation the two lower windshields broke, and the belly shell structures have multiple scratches and gouges in the honeycomb structure.
