Claim	: 20733
Aircraft	: Bell 206 BIII
Location	: Guayaquil Naval Air Station, Ecuador
Being offered	: As is where is
Contact Information	: Pablo Bañuelos Marquez; <a href="mailto:pablobanuelos@aav.global">pablobanuelos@aav.global</a>

Helicopter built in 1980, serial number 2966, it has 10,174 total flight hours since new.

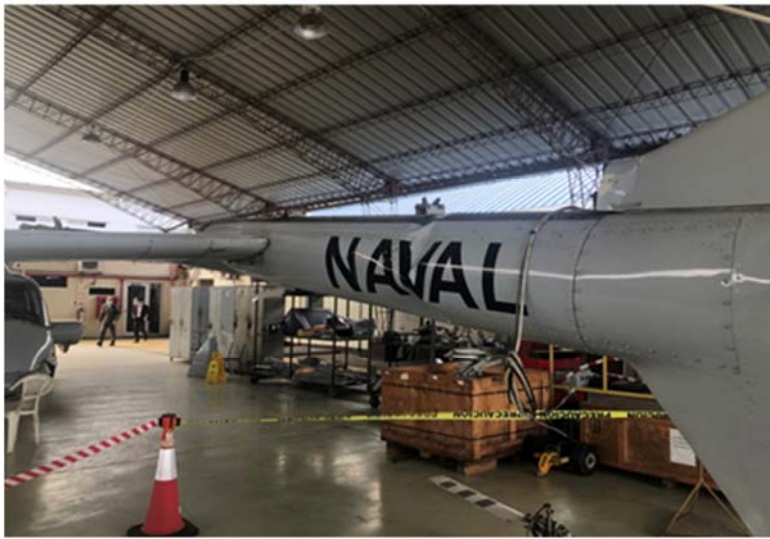
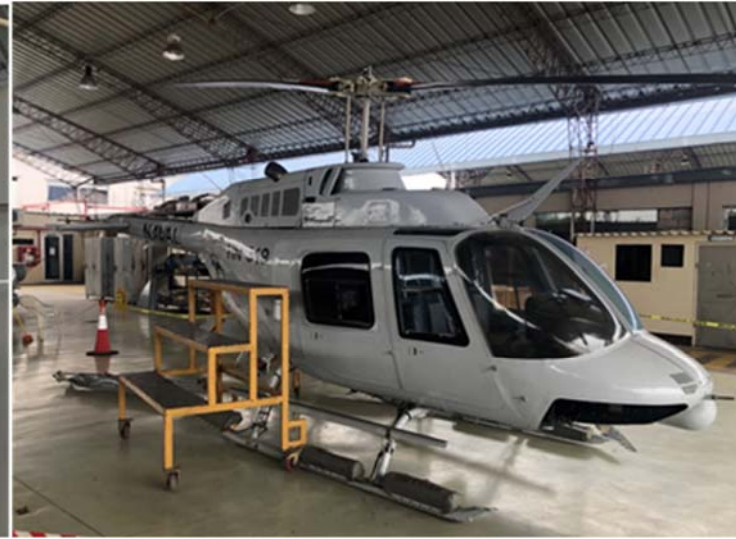
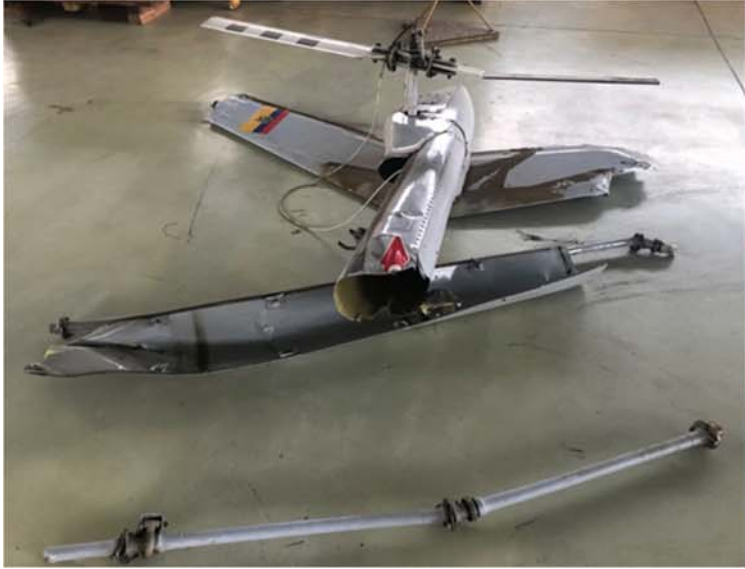
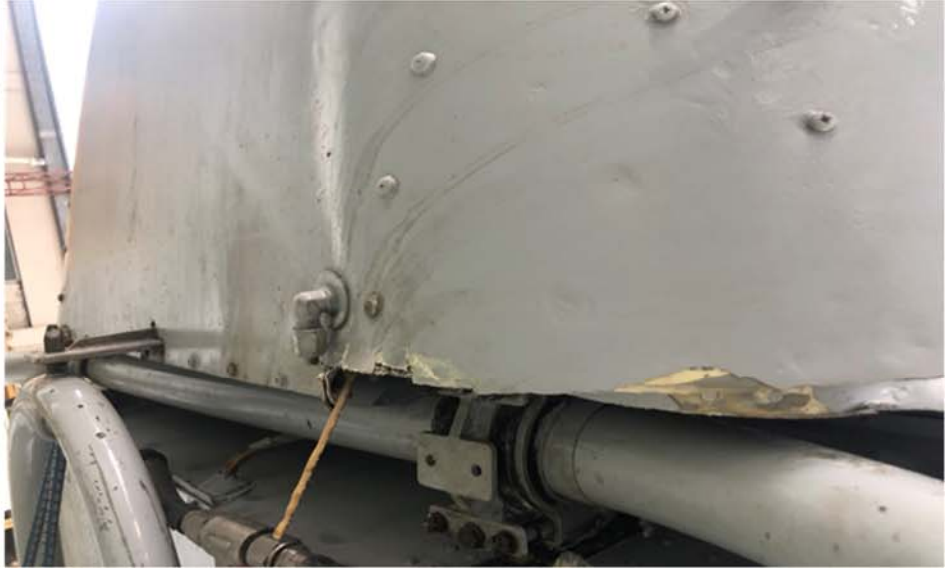
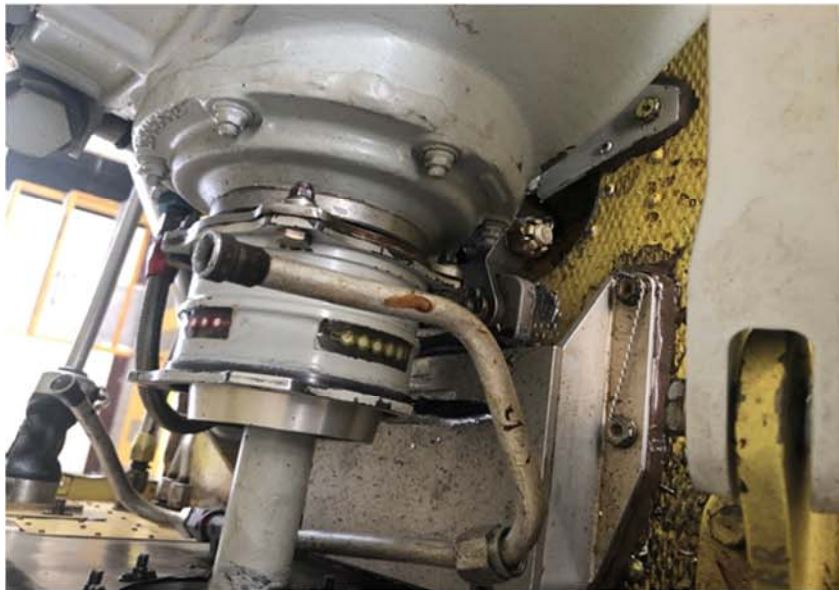
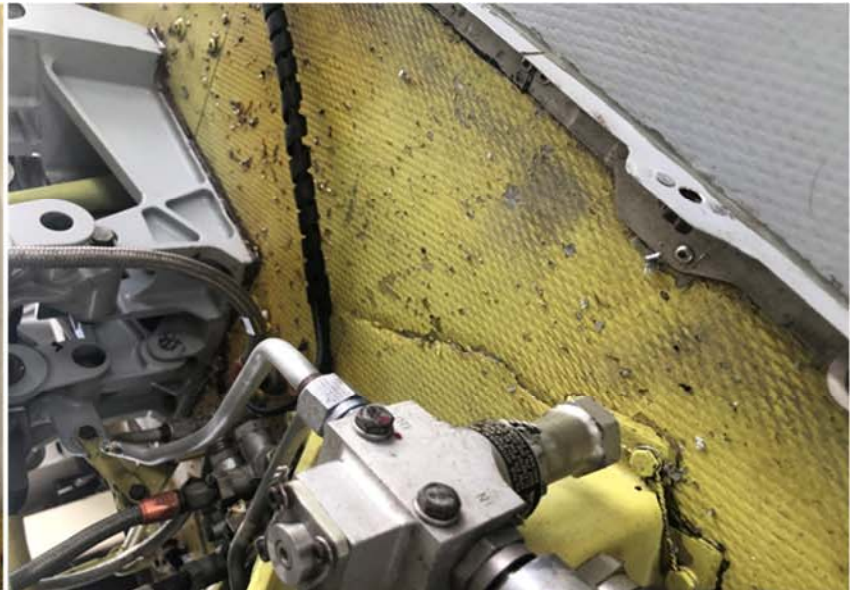
On 15<sup>th</sup> October 2020, during a training session, the instructor pilot reduced engine power after take-off to simulate an engine stoppage. The pilot-in-training attempted to land but brought the cyclic stick backwards at touchdown and the main rotor blades came down and chopped off the tail rotor assembly and fin. The helicopter landed very heavy with low rotor RPM

The vertical fin, transmission and all the tail section (tail boom, tail rotor gearbox, tail rotor blades, tail rotor hub assembly and tail rotor shafts) are scrap • The undercarriage is splayed, so the cross tubes need replacing • The engine requires hard landing and sudden stop inspections • All the avionics need to be bench-tested. •
