Claim	: 20637
Aircraft	: MD530F helicopter
Location	: GPM Aeroservicio, near Toluca International Airport, State of Mexico
Being offered	: As is where is
Contact Information	: Pablo Bañuelos Marquez; pablomanuelos@aav.global

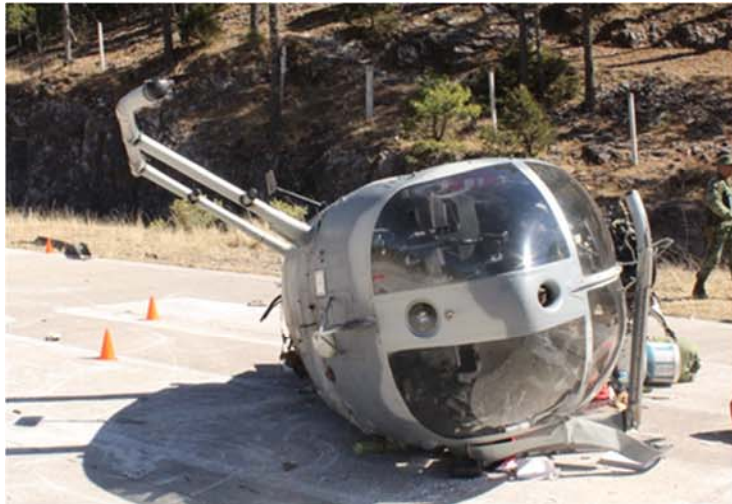
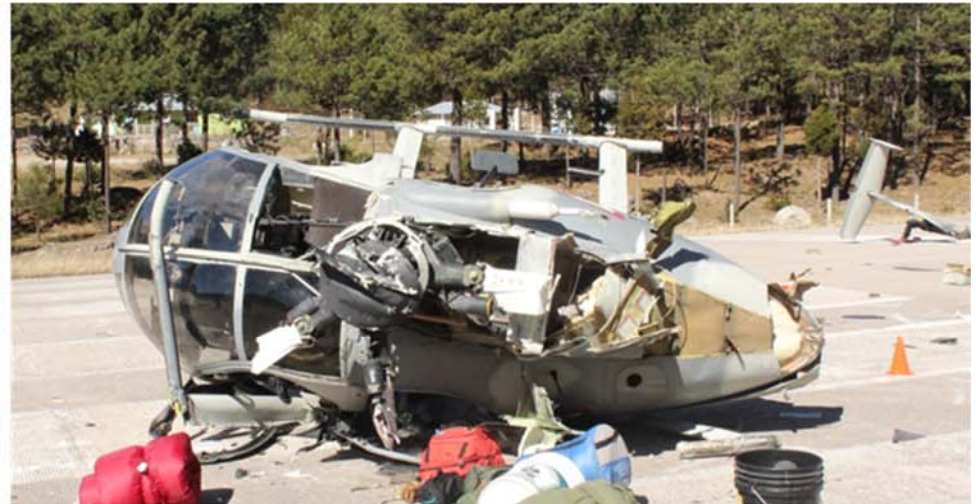
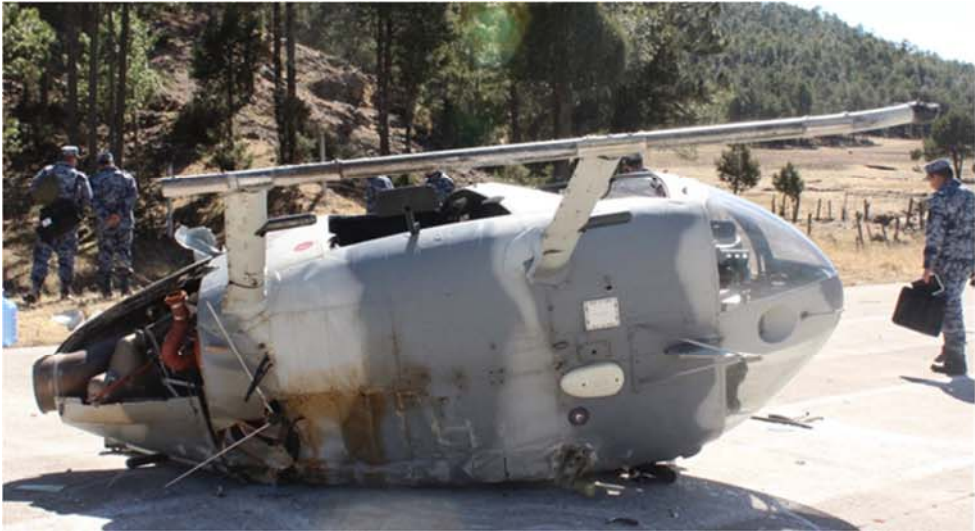
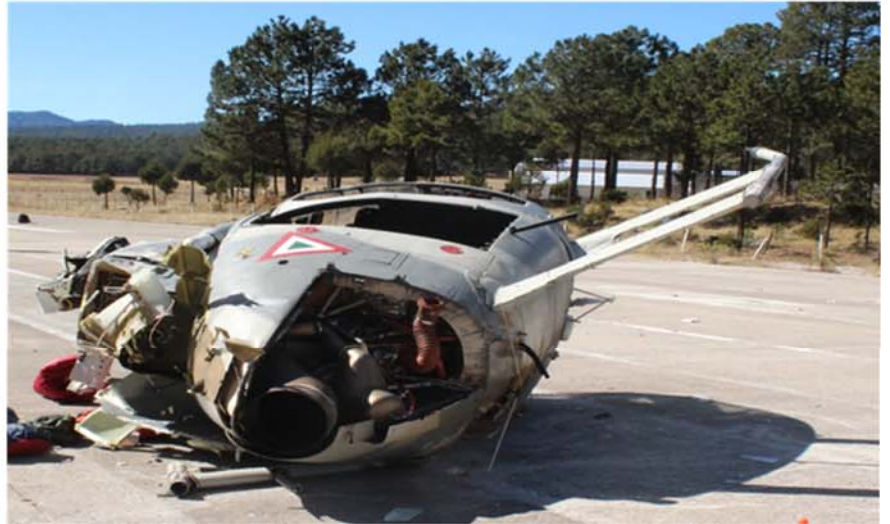
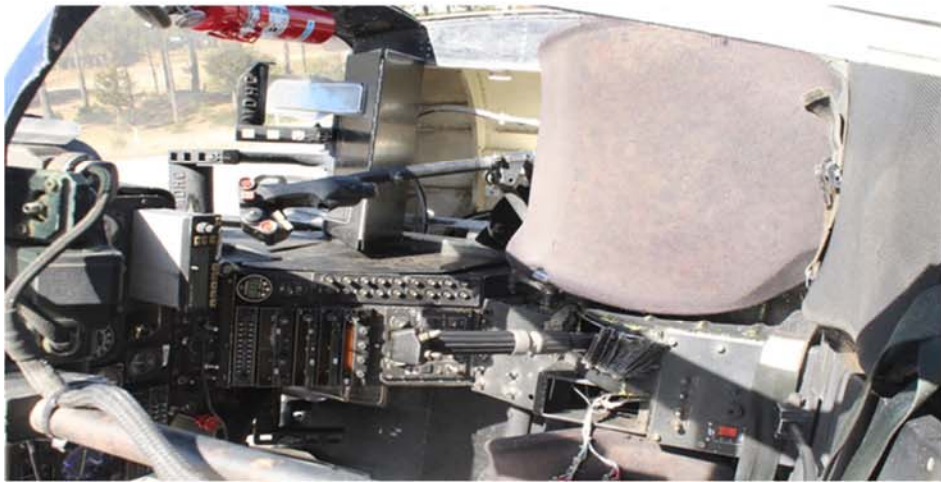
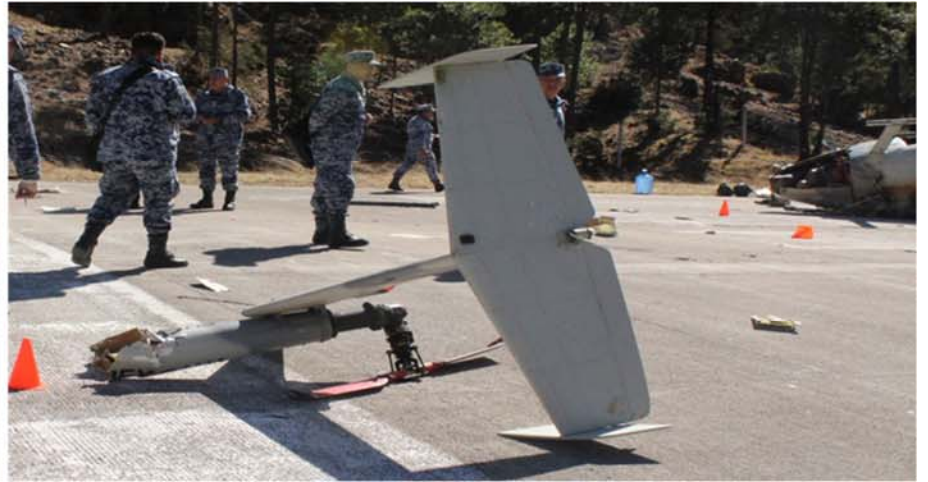
On 19<sup>th</sup> January 2020, while descending to land at the airstrip of the Army Operations Base #1, in Guadalupe y Calvo, Chihuahua, the helicopter descended rapidly, hit the ground with the left landing skid first at a very high rate of descent, the skid broke and rolled over.

- Deformation and distortion throughout the airframe • All dynamic components are considered scrap • The main rotor blades broke and detached • The undercarriage is scrap; the left skid broke and separated • The tail rotor section broke and detached • The rotating components of the engine are considered scrap.
