Claim	: 20326
Aircraft	: Gulfstream G200, N813WM
Location	: Tegucigalpa, Honduras
Being offered	: As is where is
Contact Information	: Julio Garcia – juliogarcia@aav.global

Accident Circumstances

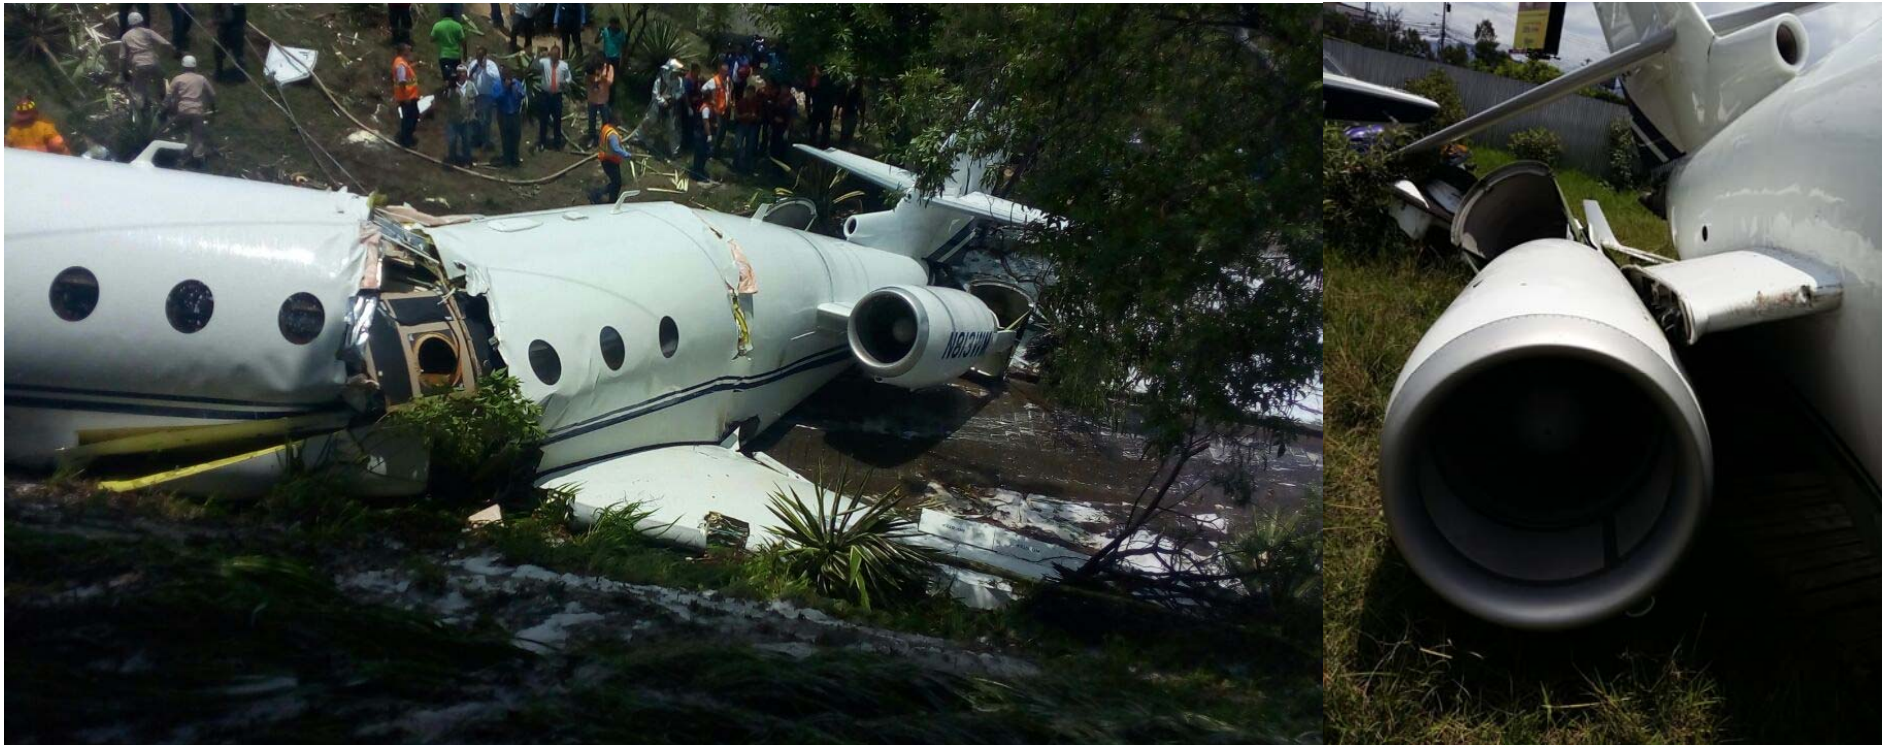
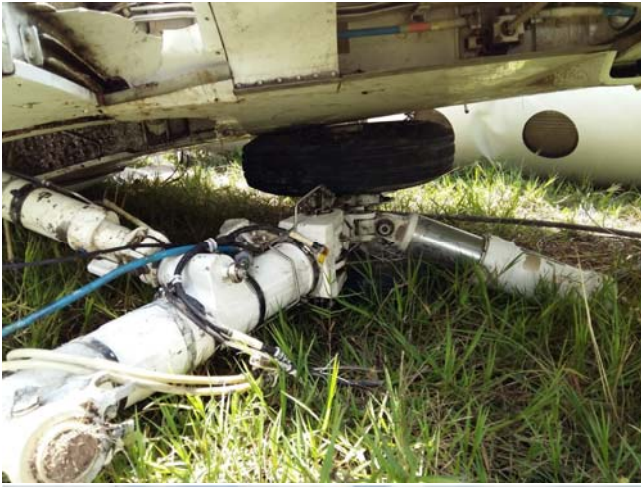
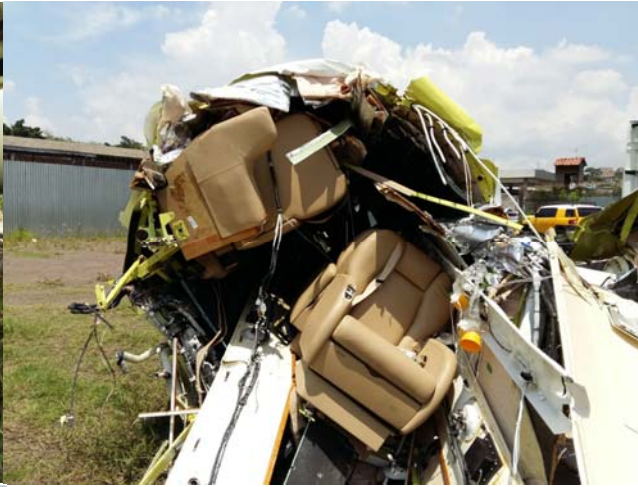
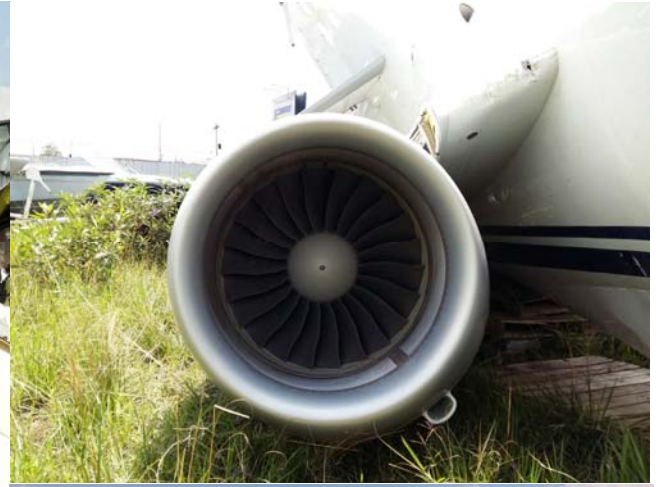
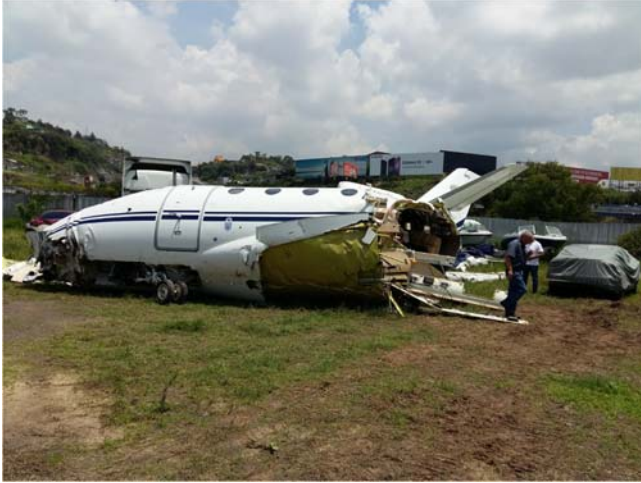
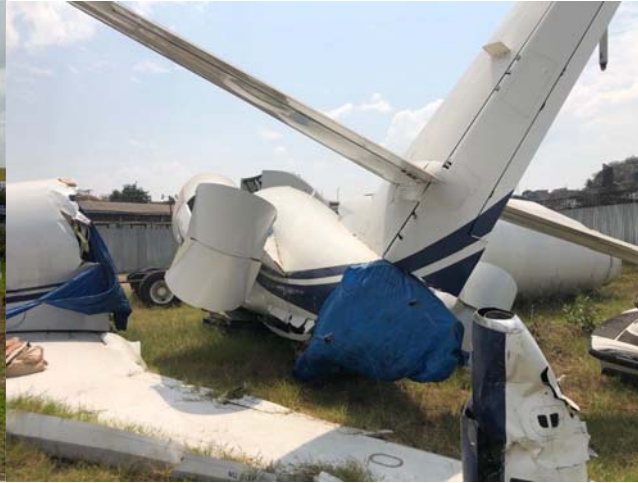
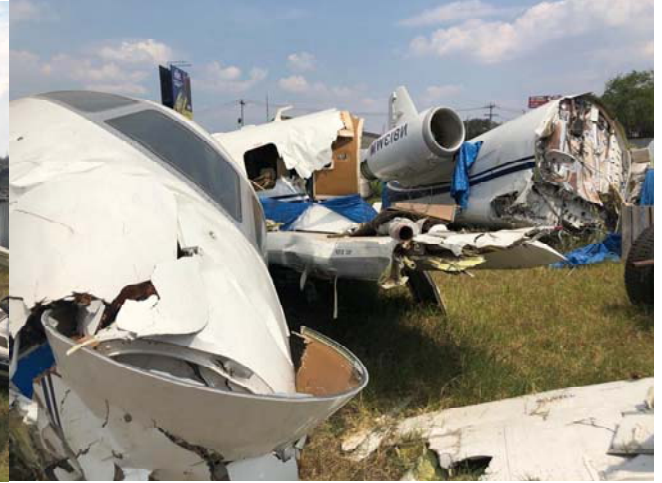
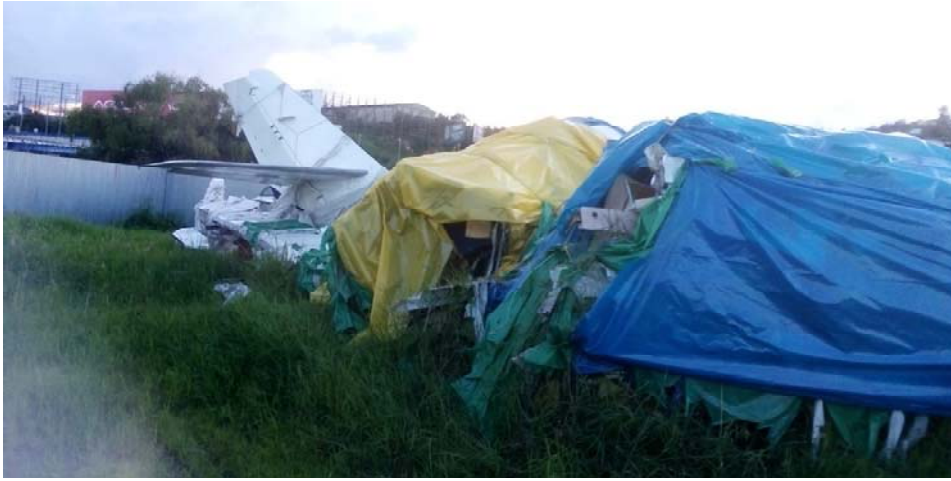
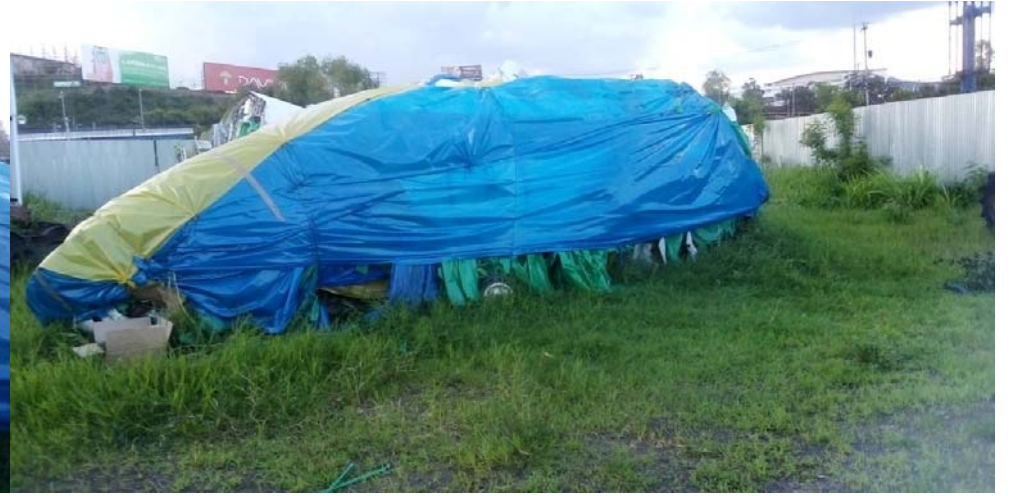
Please refer to the photographs

The aircraft fuselage was distorted and broke into 3 segments. The landing gear was severed. The aircraft was recovered and move for safekeeping at a truck parking lot near the Airport.
