Claim	: 20671
Aircraft	: RPA S-4“Ehécatl”
Location	: Hydra Technologies facilities, Zapopan, Jalisco, Mexico
Being offered	: As is where is
Contact Information	: Pablo Bañuelos. pablobañuelos@aav.global

Hydra Technologies S-4 “Ehécatl” Remotely Piloted Aircraft (RPA), serial number 29.

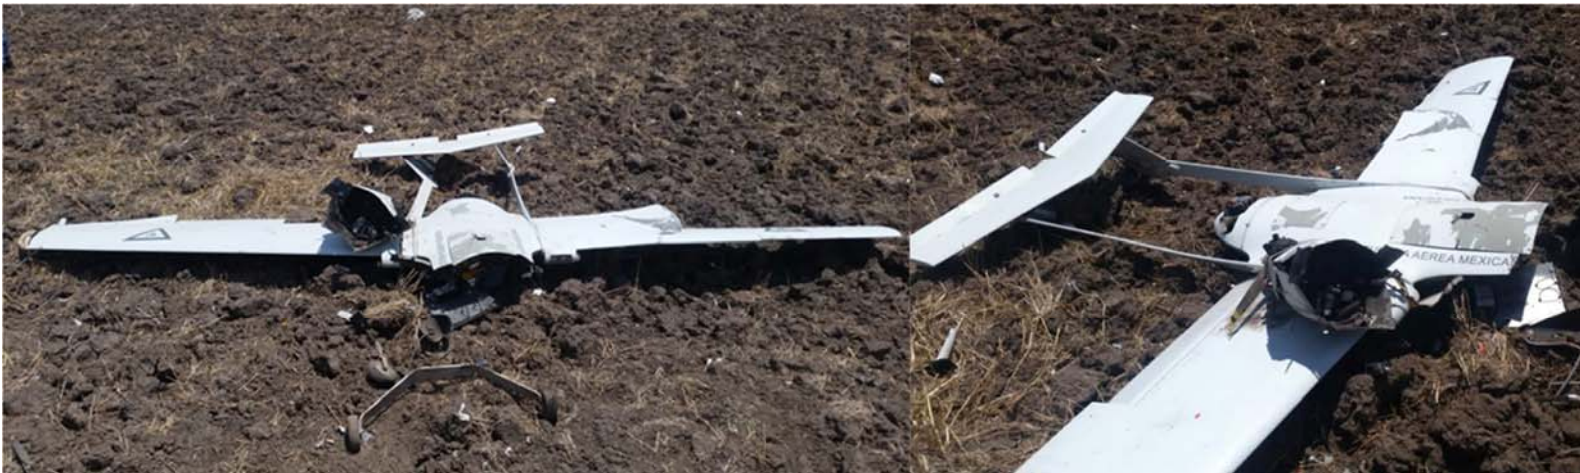
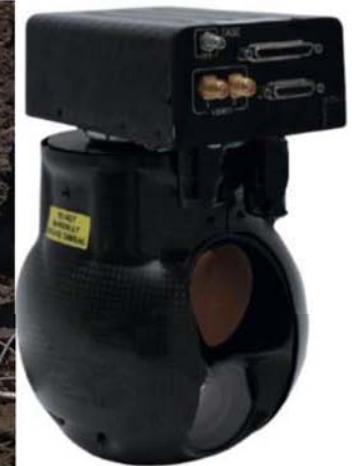
Aircraft Damage

On 22nd April 2020, during a training and systems verification flight, the pilot-operator incorrectly increased the angle of attack of the drone without applying enough power; therefore, the wing lost lift and stalled. The aircraft spun out-of-control into the ground

The airframe, undercarriage, propellers, fuel tank, antennas, electrical wiring, cargo bay, camera bay, and antennas are junk. Both motors need repair. GPS, INS and Datalink systems must be inspected. The surveillance camera (Tigre II) was not installed on the aircraft when it crashed.
