Claim	: 20824
Aircraft	: MD530F helicopter
Location	: Military Air Base #1, Santa Lucia, State of Mexico
Being offered	: As is where is
Contact Information	: Pablo Bañuelos Marquez; <a href="mailto:pablobanuelos@aaav.global">pablobanuelos@aaav.global</a>

### Aircraft Details

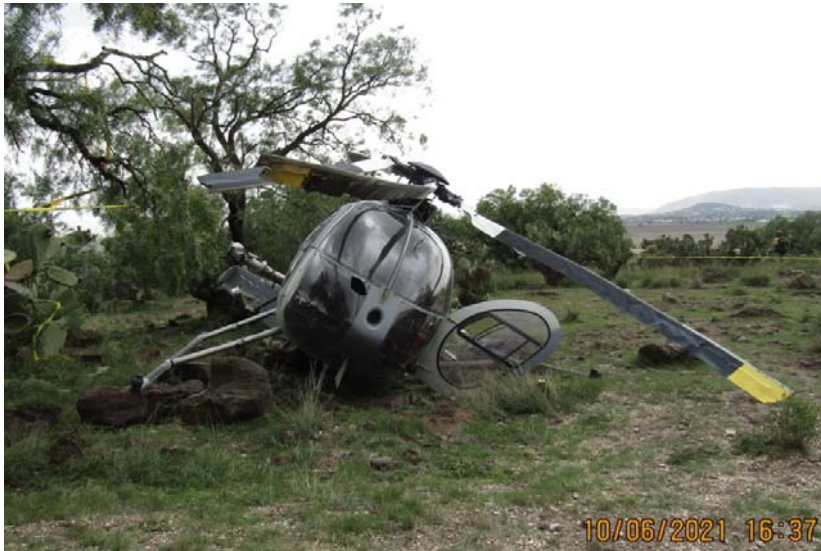
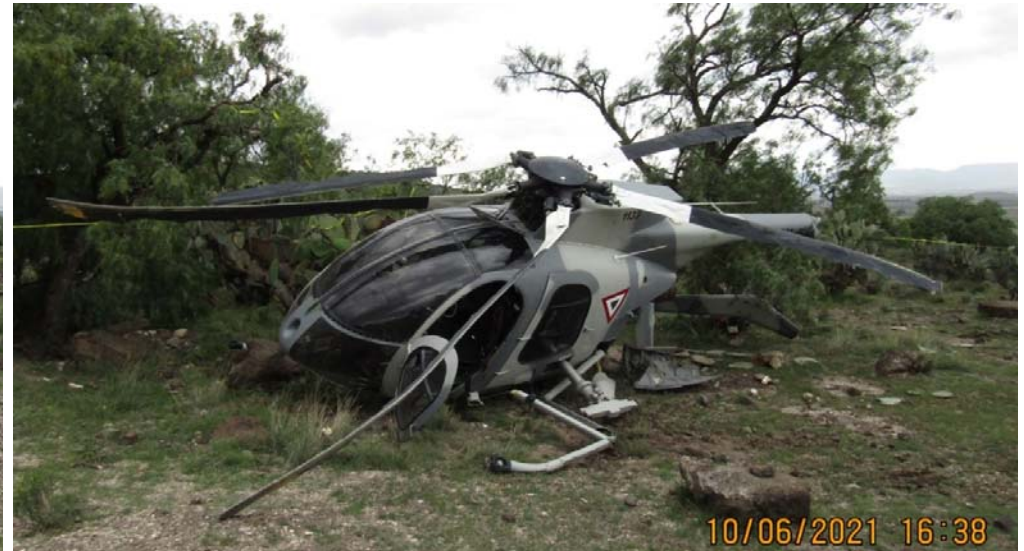
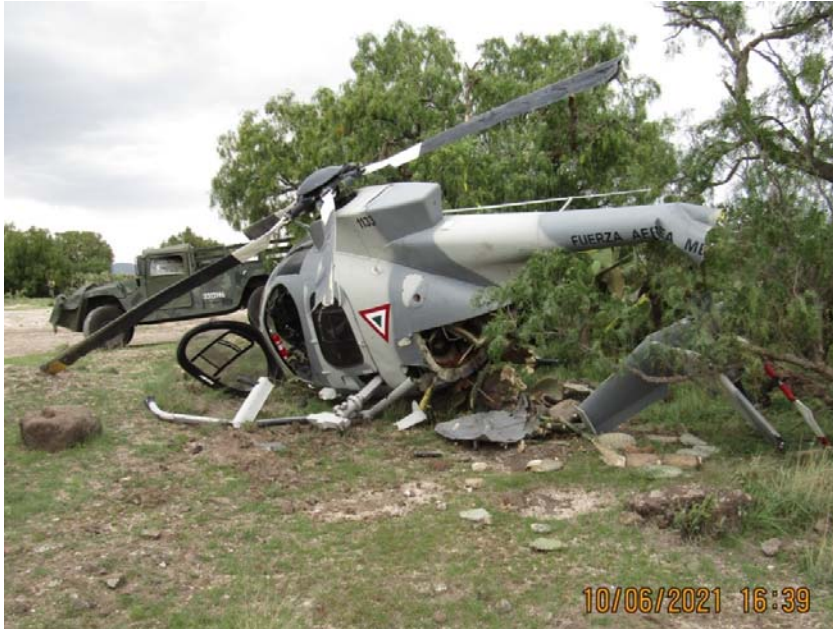
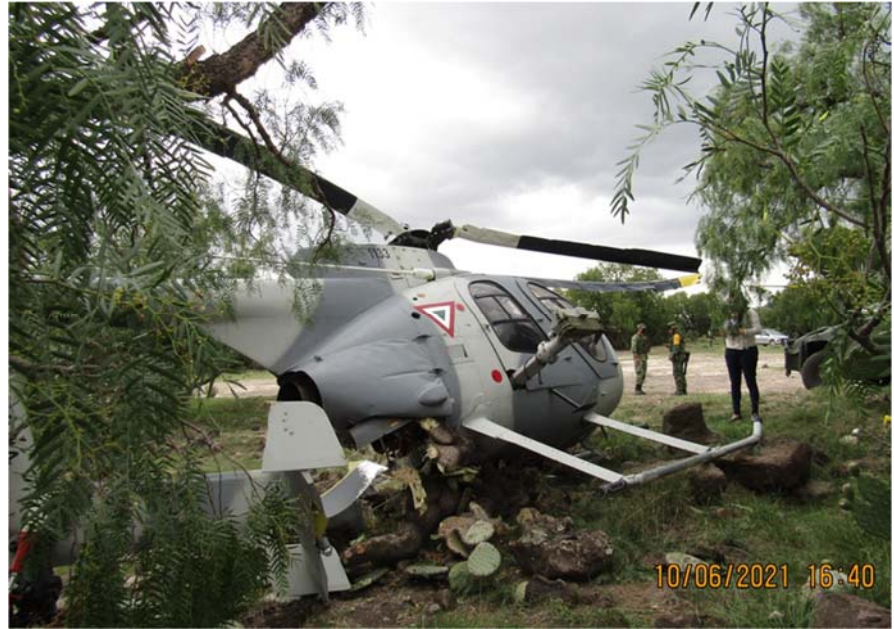
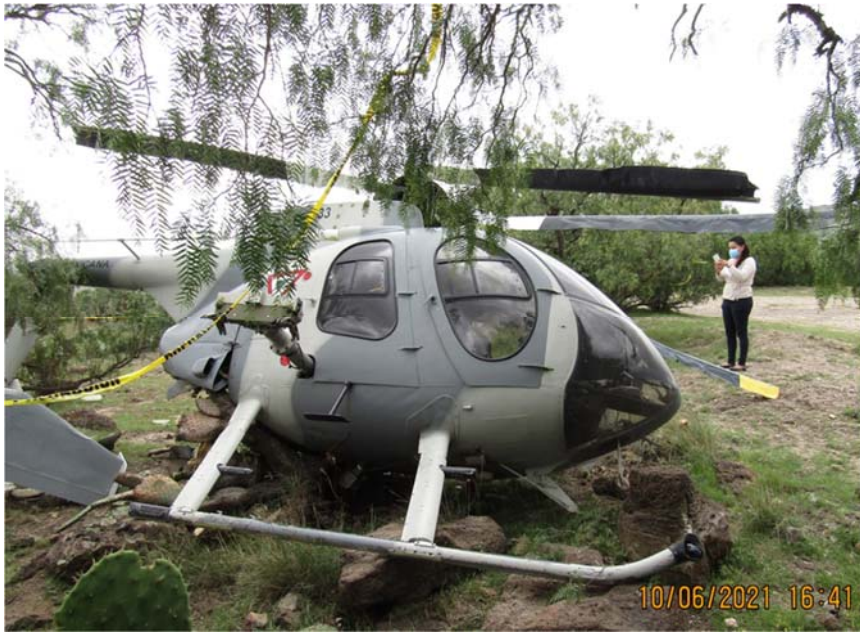
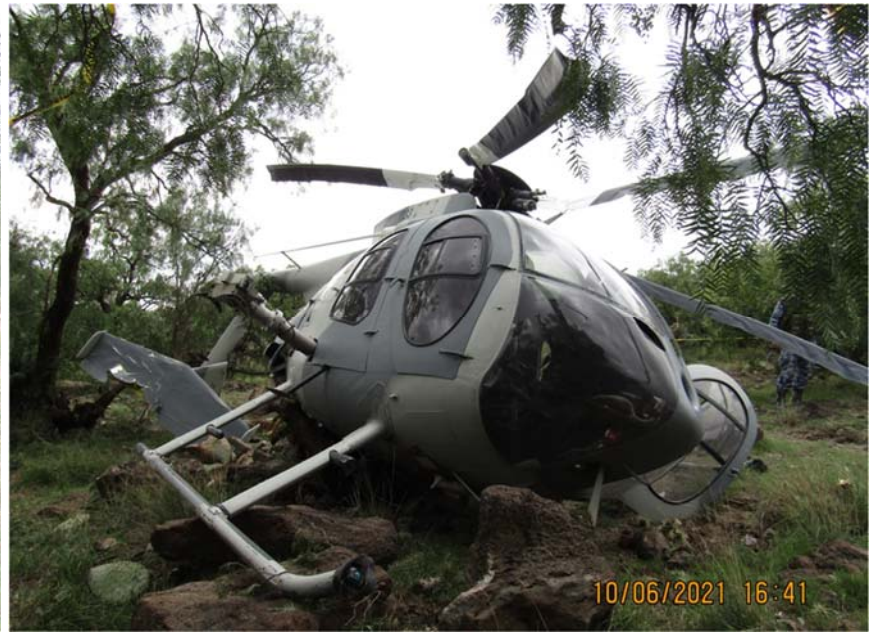
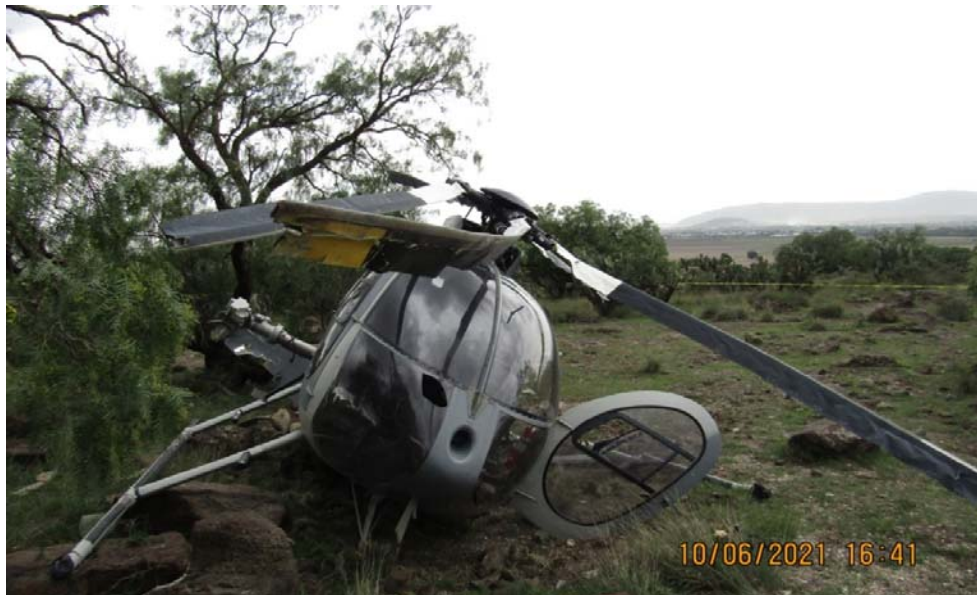
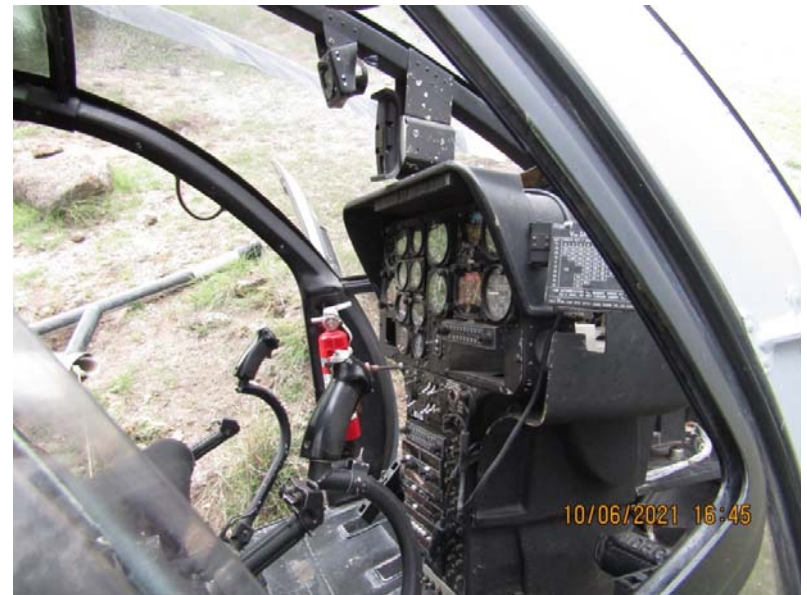
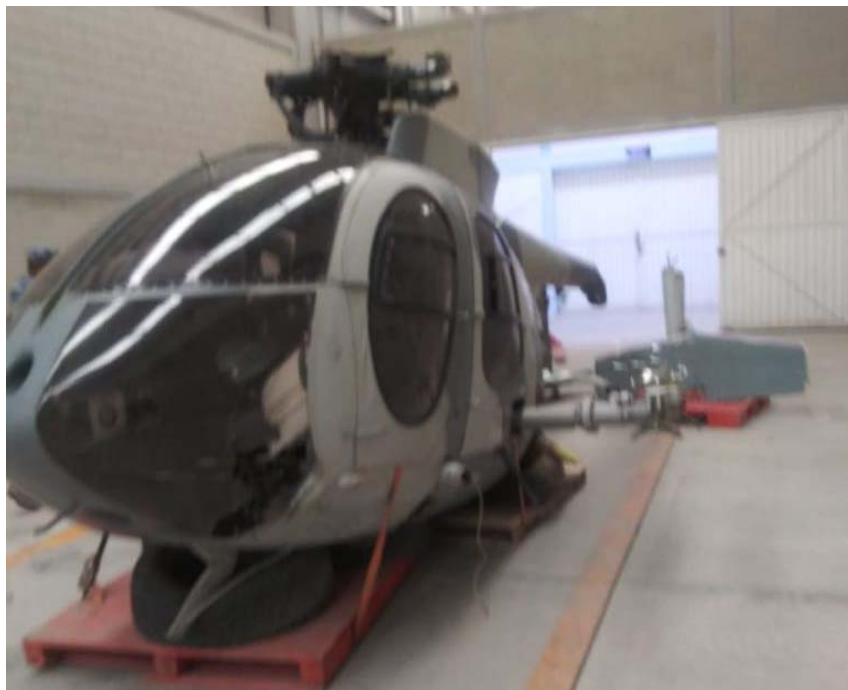
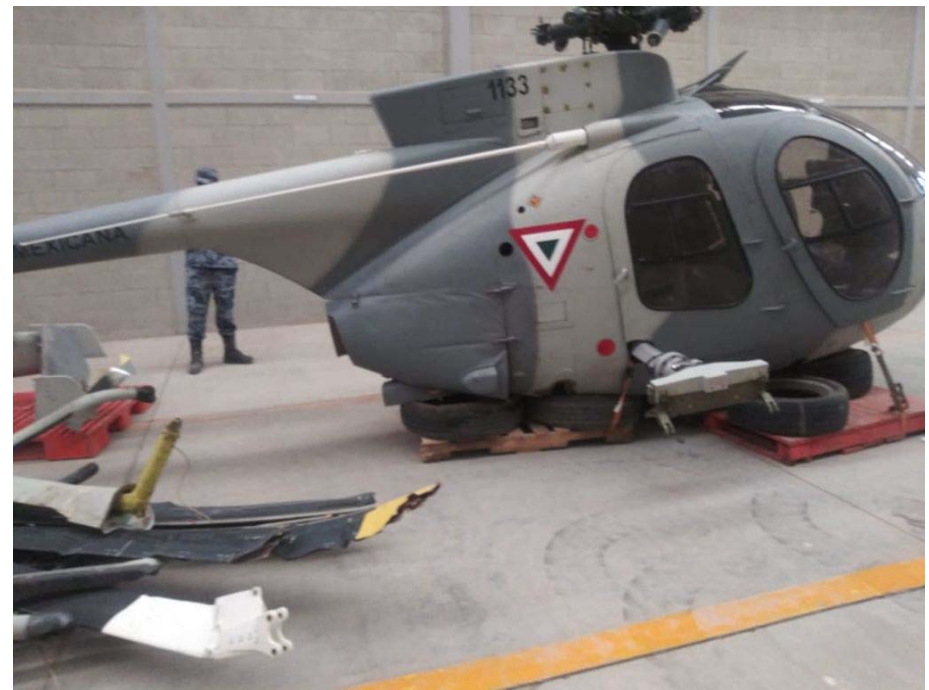
*Please refer to the photographs*

- Deformation and distortion throughout the airframe • All dynamic components are considered scrap • The main rotor blades are broken and bent • The undercarriage is destroyed • The tail rotor section detached and is severely damaged • The rotating components of the engine are considered scrap.
